Intel[®] Celeron[®] Processor Specification Update

Release Date: July 02

Document Number: 243748-046

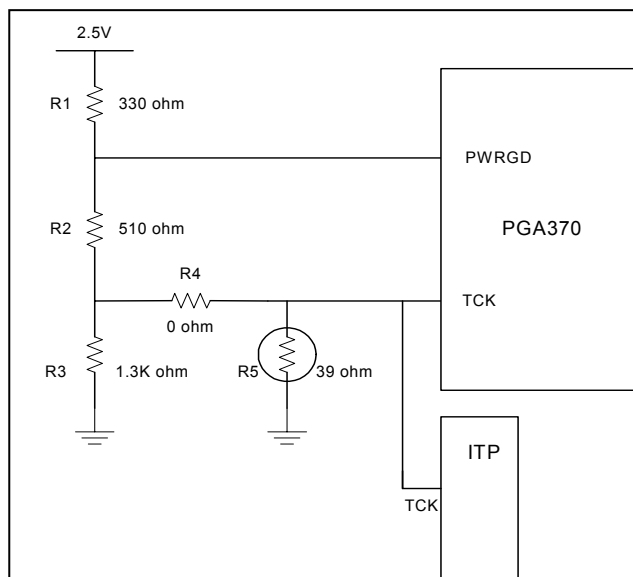
Figure 1 Celeron® on 0.13 Micron Processor 256K Platforms Workaround

In addition, the example workaround circuits shown do not support production motherboard test methodologies that require the use of the processor JTAG/TAP port. Alternative workaround solutions must be found if such test capability is required.

For Production Boards:
Depopulate R5

To use ITP:
Install R5, Depopulate R4
